**REMEDIAL ACTION COMPLETION REPORT
SOUTH DISTRICT WORK CENTER
1851 SOUTH 34TH STREET
PHILADELPHIA, PENNSYLVANIA 19145**

**PADEP Facility ID: 51-3000
Leidos Project 303167.TM.100039.1000.0100**

April 2015

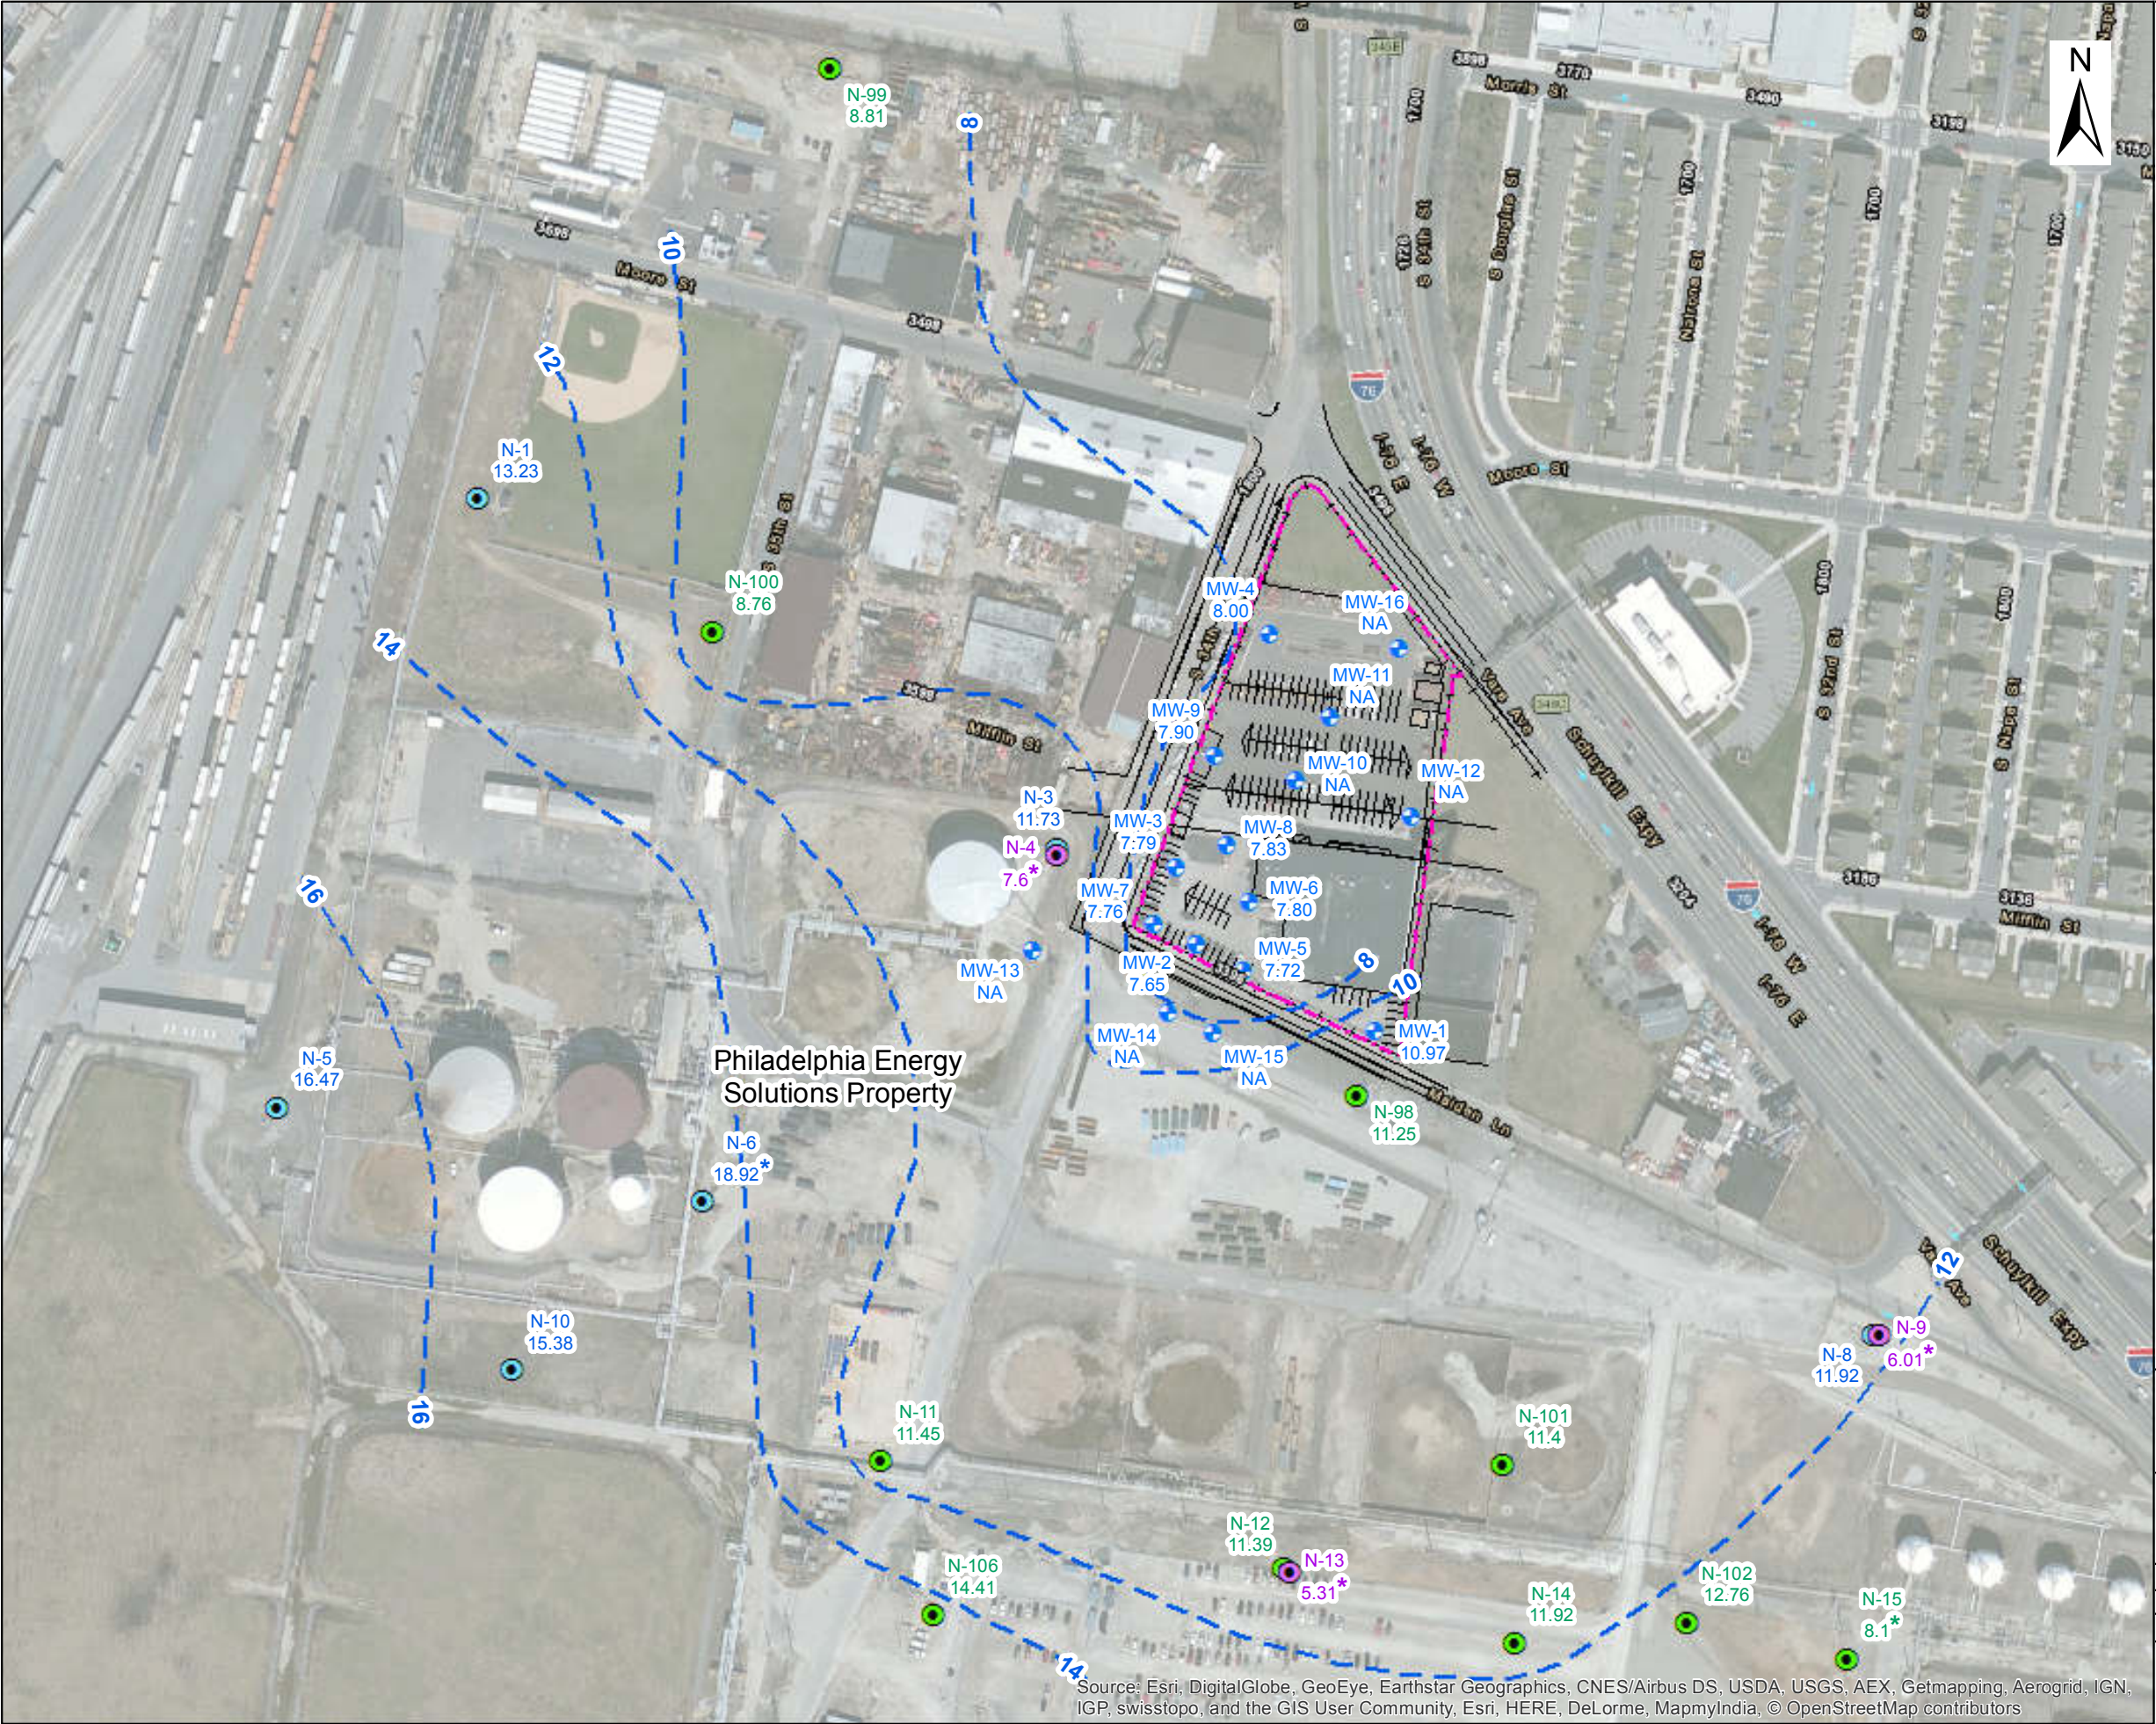
drawn	JWS	checked	MDM	approved	CDO	figure no.
date	02/25/2015	date	02/25/2015	date	02/25/2015	7
job no.	file no. VZ-Sunoco_GW_Cont_May2011

- Shallow Site Monitoring Well
- Shallow Zone Monitoring Well (Installed by PES)
- Intermediate Zone Monitoring Well (Installed by PES)
- Deep Zone Monitoring Well (Installed by PES)
- Fence
- Verizon Property Boundary
- 74.95 Groundwater Elevation in feet above mean sea level (AMSL)
- NA Not Available
- Groundwater Elevation Contour in feet AMSL (Dashed where inferred)
- * Value Not Included in Contouring
