RE: Sitewide Remedial Investigation Report Addendum Former Philadelphia Refinery PADEP eFACTS Primary Facility ID # 780190 (Sitewide) EPA PAD 002 28 9700 3144 Passyunk Ave, Philadelphia, PA, 19145

To: Tiffani Doerr, P.G. – Evergreen Resources Management Operations
 From: Andrew Buchy and Colleen Costello, P.G. – Sanborn Head & Associates, Inc.
 File: 4796.00
 Date: October 17, 2022
 Re: Evergreen Response to August 18, 2022 Pennsylvania Department of Environmental Protection (PADEP) Technical Deficiency Letter and Technical Memo Summary for the Site Wide Remedial Investigation Report Addendum – Appendix C – Eastern Tank Farm Cumene Investigation

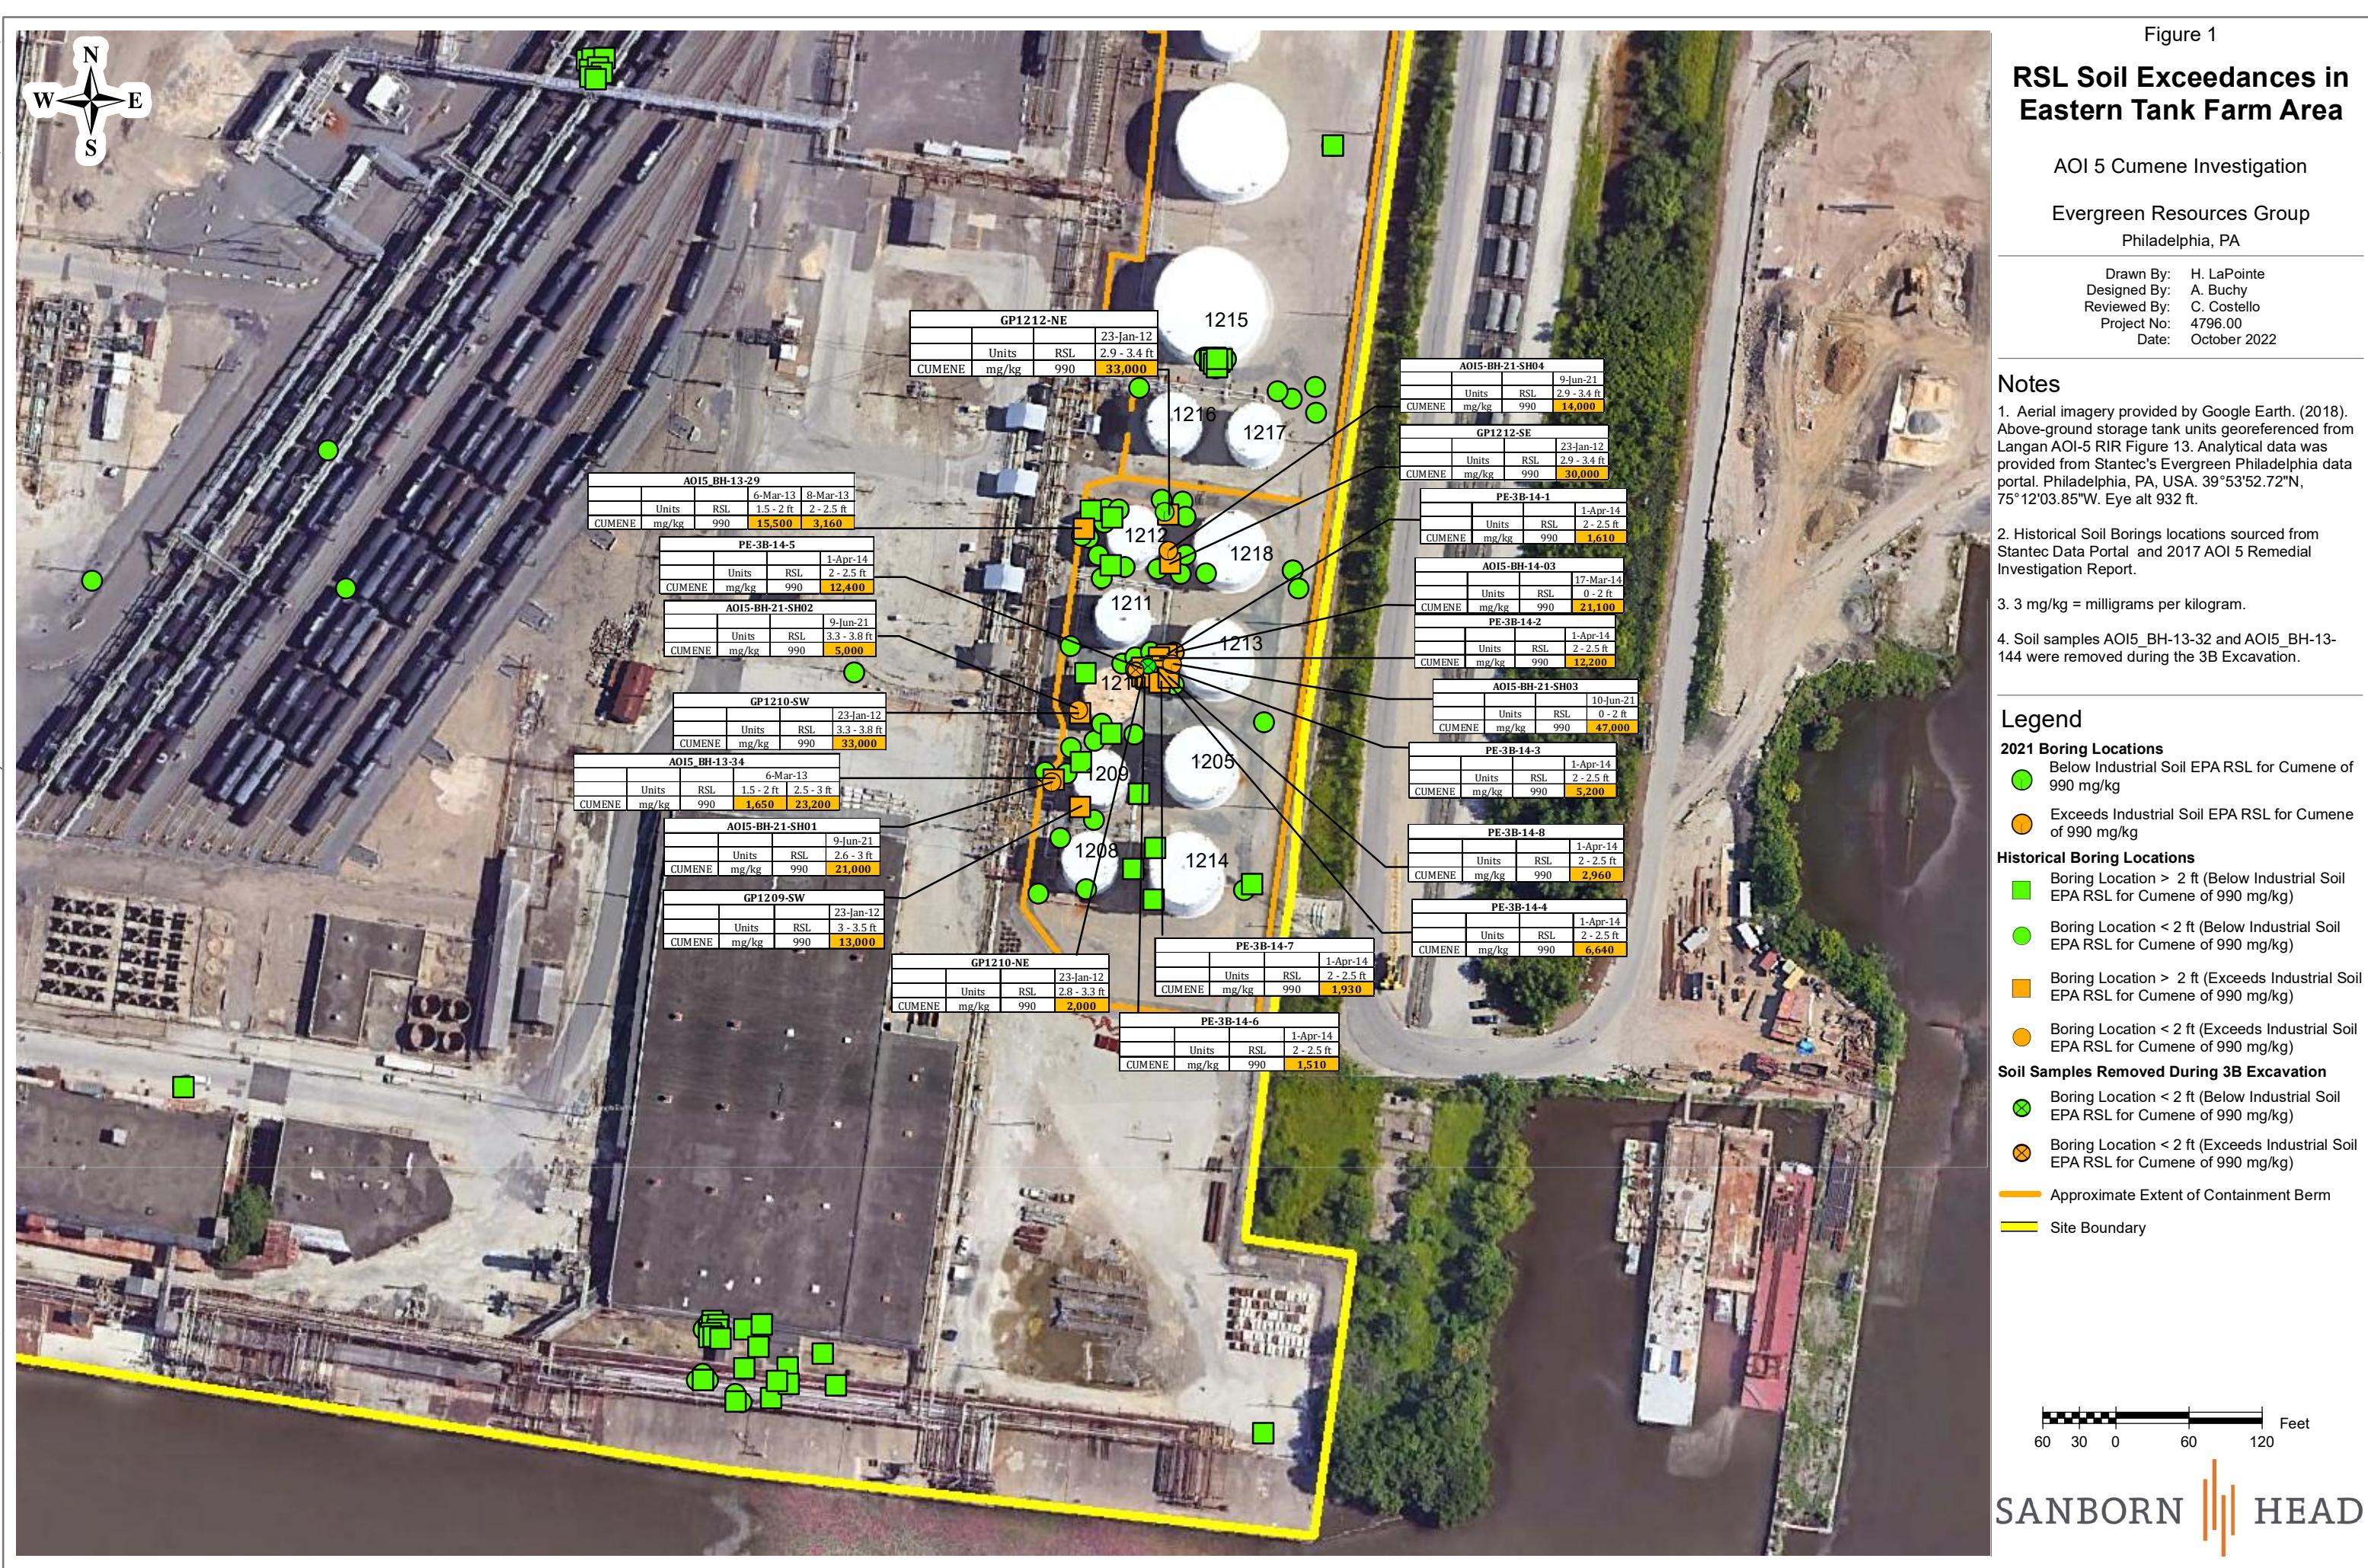
SL Sample was collected below LNAPL

- Exceeds Industrial Soil EPA RSL for Cumene

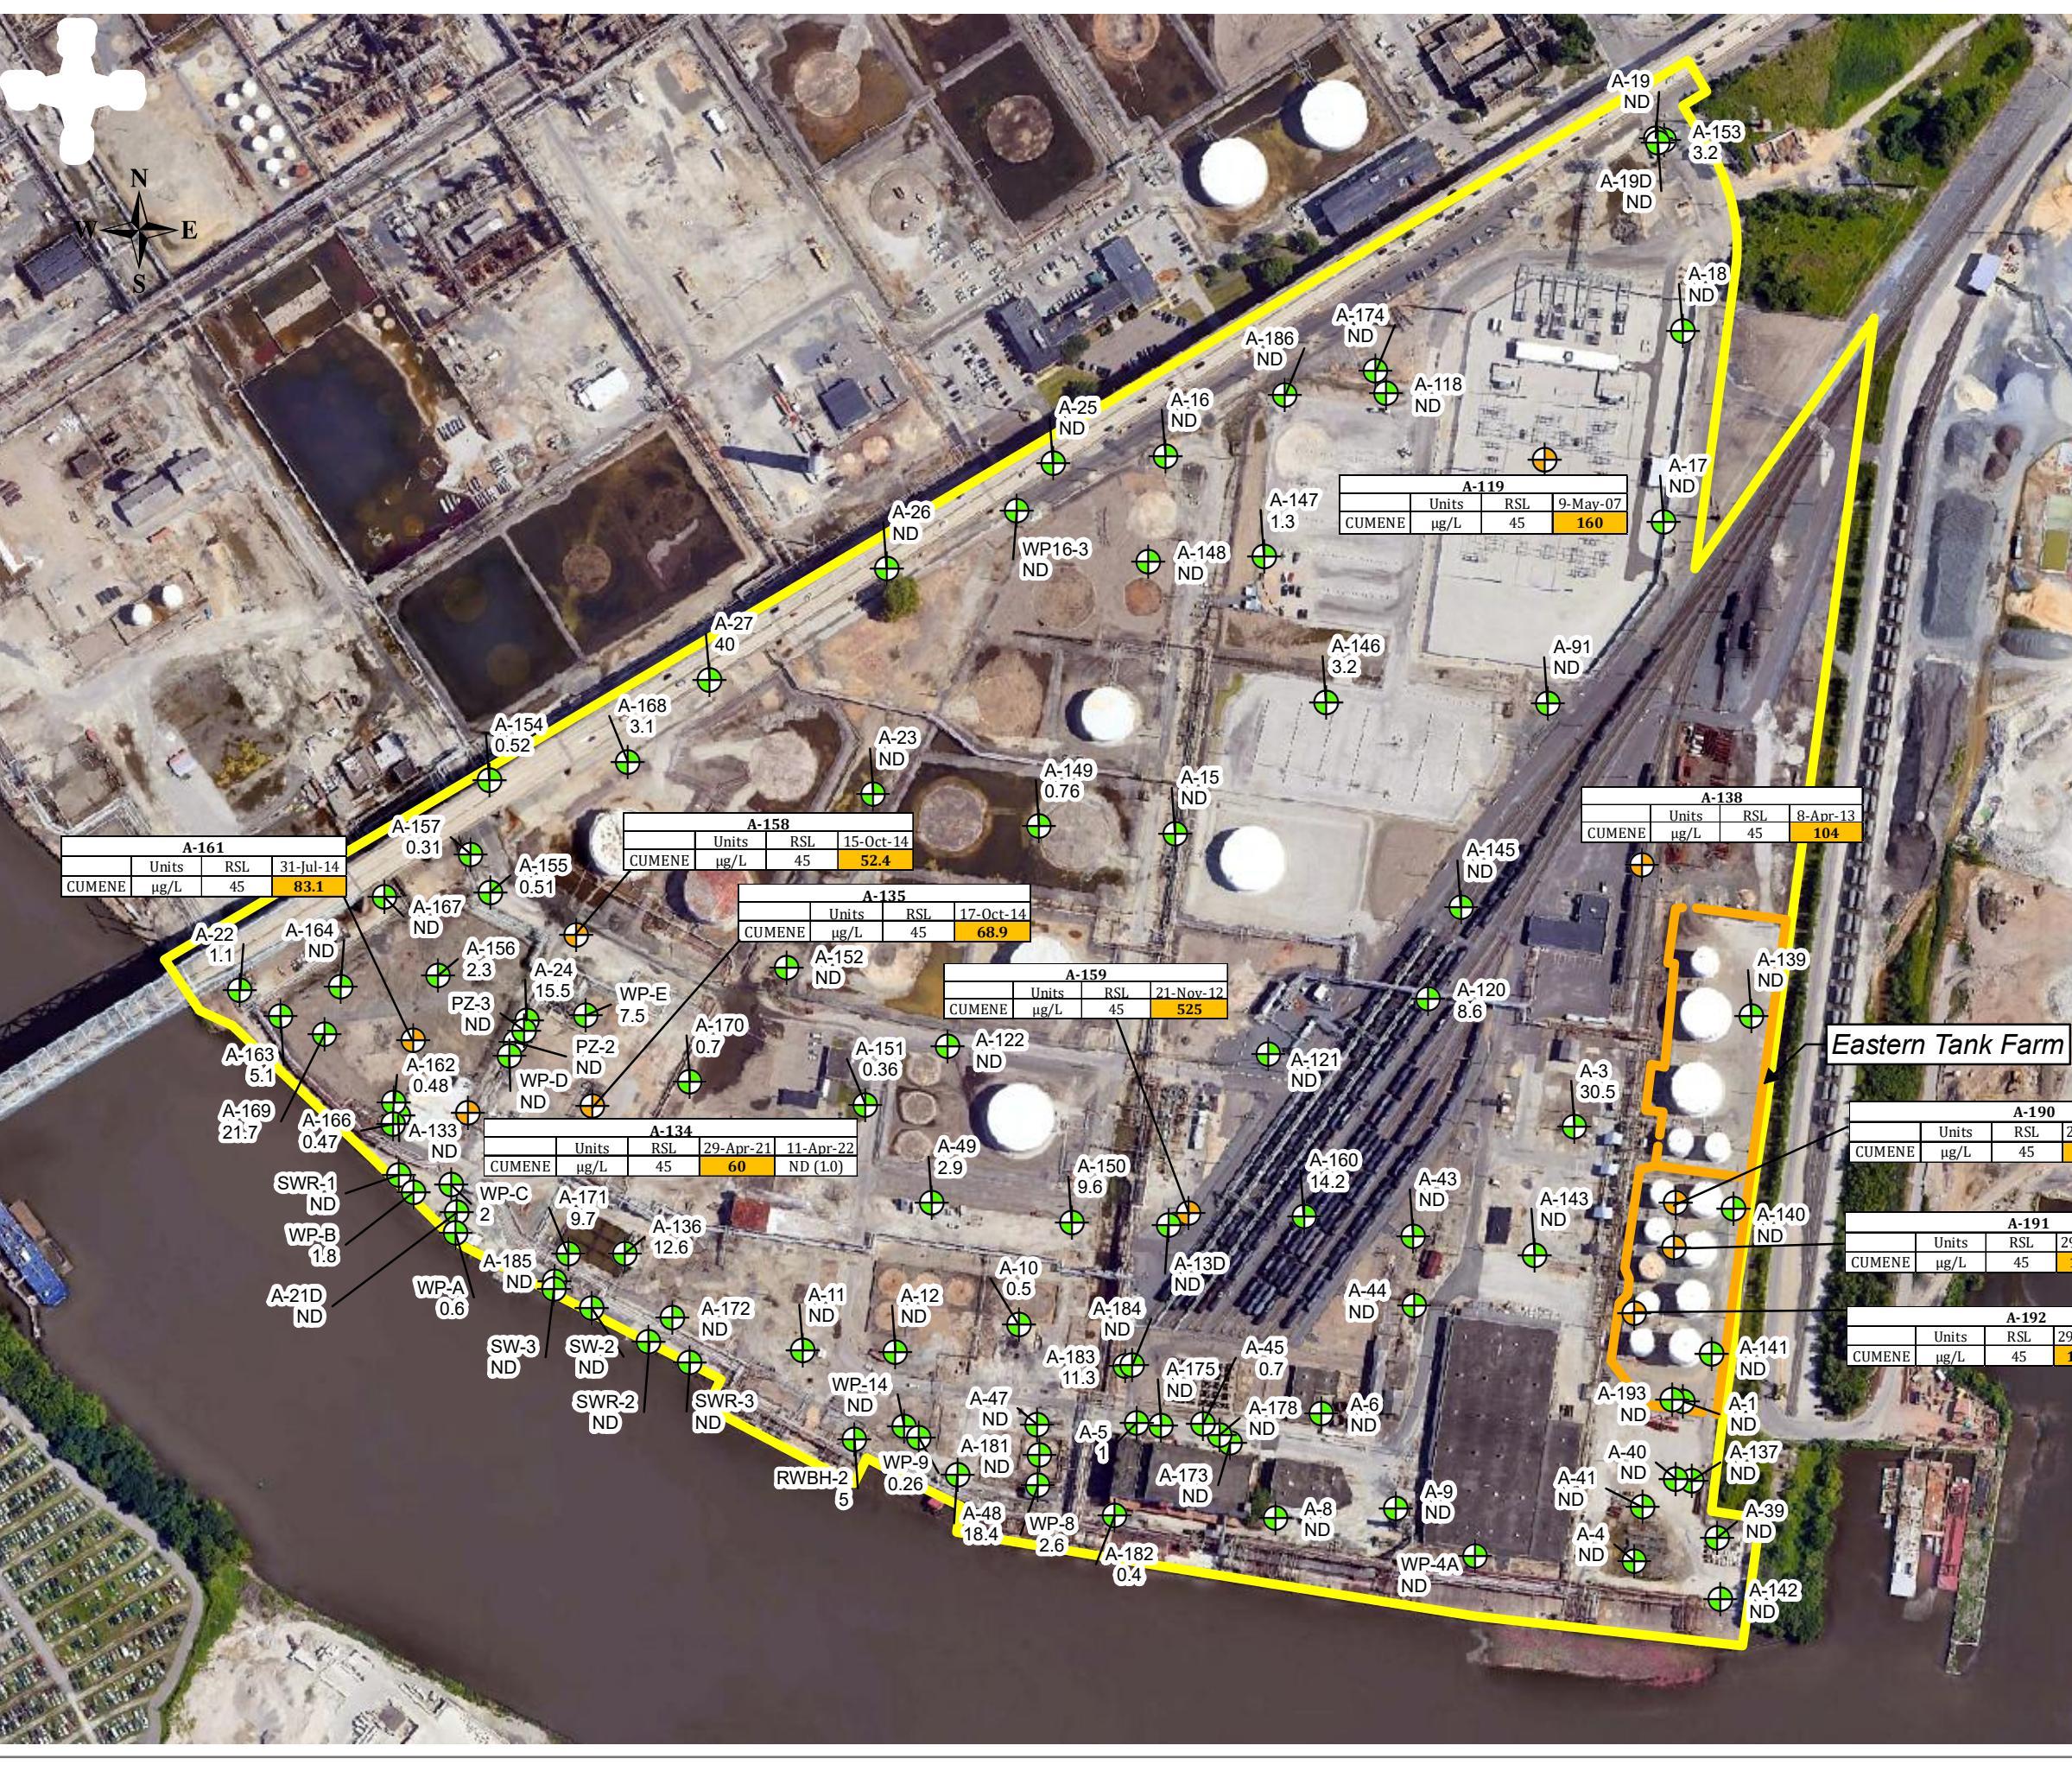
Figure 2

19174 A-190 RSL 29-Dec-21 11-Apr-22 45 **8,600 7,740** Units µg/L A-191 RSL 45 9-Dec-21 12-Apr-22 9.180 A-192 RSL 29-Dec-21 12-Apr-22 45 18,000 4,420

- Monitoring Well Cumene Concentration Above Tapwater RSL of 45 ug/L
- Monitoring Well Cumene Concentration Above Tapwater RSL of 45 ug/L \oplus
 - Approximate Extent of Tank Farm
 - AOI 5 Boundary

Table 2 and **Figure 2** in **Attachment 1** compare historical cumene groundwater monitoring results in comparison to the RSL for Tap Water. As shown on **Figure 2**, cumene groundwater results were delineated to the RSL for Tap Water within AOI 5. It should be noted that the correct RSL for water has not been determined; therefore, the most conservative value for Tap Water has been utilized for this response.
